Howard SEDDING<sup>1</sup>, Mark FENGER<sup>1</sup>, John KUFFEL<sup>2</sup> and Edmund KUFFEL<sup>2</sup>

Kinectrics Inc (1), University of Manitoba (2)

## Recent experiences with after-laying tests of solid dielectric transmission class cables

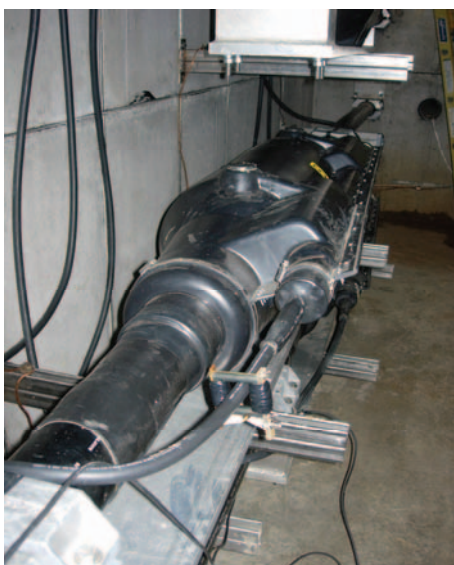
Fig. 3. Photo of HFCT sensor in MH #2

Signal coupling is provided by attaching a High Frequency Current Transformer (HFCT sensor) around the ground link from the cable joint towards the link-box. High frequency currents induced as a result of any partial discharge activity occurring in the joint or in the cable section will be coupled to the HFCT sensor and measured by a conventional partial discharge monitor. Figure 3 shows a HFCT sensor placed around the ground link of a joint in a typical configuration.

The phase angle reference is provided by a low-frequency winding embedded in the HFCT sensor itself. In addition, the operator would check the waveform of the signal activity measured via an oscilloscope to confirm the signal strength as well as confirm the presence of PD or noise.

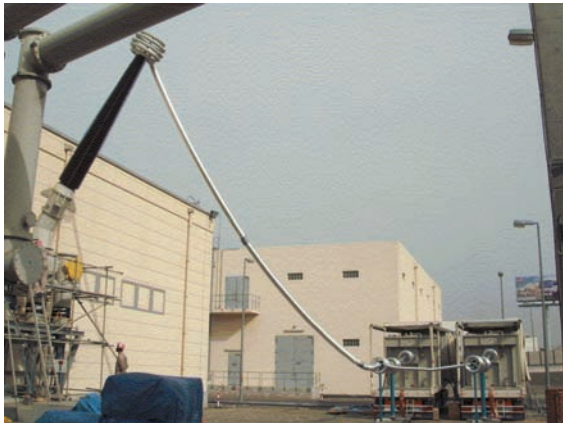
Fig. 4a. Parallel setup of two resonant test systems for testing an 11-km 380-kV cable installation

The following discussion of field experience is based on numerous tests performed in various locations in the Middle East and North America. All of the cables were XLPE-insulated spanning the voltage range of 66 through 380 kV with circuit lengths ranging from 3 to 15 km. Typically, those circuits rated at 220 kV and above required the use of two resonant test systems operating in parallel. Figure 4 shows two parallel connected resonant test systems set up for testing a 380-kV and a 220-kV cable installation.

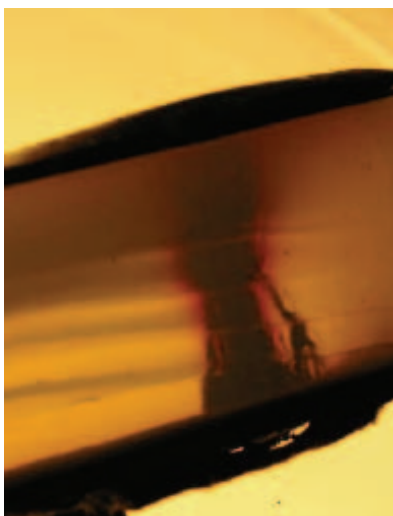
Fig. 5. Example of treeing in failed cable

Microscopic examination of the cable demonstrated that the failure had resulted from electrical treeing (Fig. 5). However, the treeing had not resulted from the inclusion of a void or contaminant but rather from mechanical damage inflicted on the cable during preparation of the cable for splicing.

Evidence from the post-failure analysis showed that significant electrical treeing had occurred prior to failure, even in the short time that the cable was at the test voltage. In principle, this type of defect should have been amenable to detection using PD measurements. However, the short time-to-failure rendered the probability of detection prior to breakdown remote. The methodology used to facilitate PD tests on these cable installations requires that a measurement be made at each joint and termination. Presently, two sets of PD test operators are deployed and these two teams leapfrog each other down the cable route. This method has the advantage that if one team considers that signals consistent with a PD source are present in an accessory, the second set of operators at the next joint can aid in confirmation using the assumption that a component of these signals will propagate to that location. However, there are obvious limitations in this strategy and, in most practical cases involving large numbers of accessories the PD test cannot be completed within the one hour time frame of the overvoltage test.

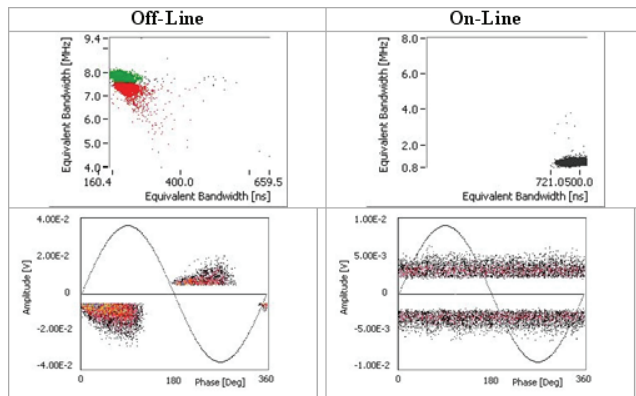
Fig. 6. Comparison of off and on-line PD test results

signal activity measured is quite different: As can be seen, the frequency content of the signals measured range from approximately 800 kHz to approximately 2 MHz. In addition, the phase resolved PD plot show the pulses measured to be located through out the AC cycle. Consequently, the data acquired during the on-line test relates to electrical noise.

The figure demonstrates that no PD signals were present during on-line tests. Had PD been present, it would have been detected simultaneously with the noise signals and would have been identifiable in the frequency domain plot of Figure 6. While there are a number of factors that may account for the differences observed above, the decision was made to put the cable in-service notwithstanding the presence of detectable PD during the off-line test. This circuit is currently operating without incident.

A critical question of concern when making PD measurements relates to the establishment of pass/fail criteria for PD magnitudes. While the simplest, and most conservative, answer is that any detectable level of PD is too high, there are many practical issues that need to be addressed among them the costs and delays introduced by replacing a section of cable or an accessory. One practical example of attempting to define PD-based acceptance criteria for commissioning testing is illustrated in Figure 6. The left side of Figure 6 displays the data acquired during the off-line test whereas the right side of the figure displays the data acquired during the on-line test. The applied voltage for both tests was  $U_0$ . The PD activity measured during the off-line test has a frequency content ranging from 7 MHz to 8 MHz. The minimum, mean and maximum PD magnitudes for the off-line data are 5 mV, 7 mV and 24 mV respectively. In addition, the phase resolved PD plot for the off-line data shows clusters of negative and positive polarity pulses centered near  $45^\circ$  and  $225^\circ$  phase angle with reference to the phase to ground voltage which are classic phase locations for phase-to-ground dependent partial discharge data. However, during the on-line tests, the
