Stanisław GRZYBOWSKI

Mississippi State University, Department of Electrical and Computer Engineering, High Voltage Laboratory

## Fiberglass distribution line pole

**Abstract.** This paper presents the study results conducted on critical flashover (CFO) voltages of the fiberglass distribution line pole and its combination with polymer and porcelain insulators. Special attention was made to evaluate the Added CFO voltages by the fiberglass pole to the insulators when pole served as a second component in the distribution line structure. Then, the data obtained from the study performed on accelerated aging of fiberglass distribution line poles is presented, followed by the discussion of the results.

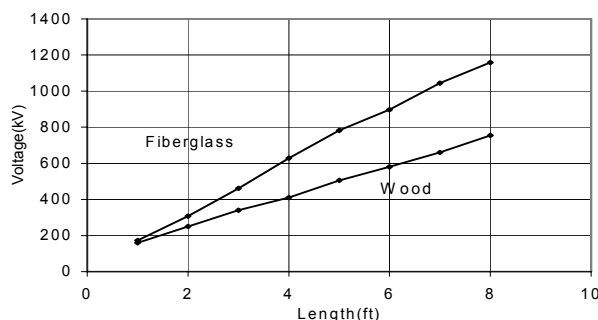
Fig. 1. The CFO voltages of the fiberglass and wood poles under wet conditions and positive polarity

Figure 1 presents the CFO voltages of the fiberglass and wood poles under wet conditions and positive polarity. It can be found the CFO voltage of the fiberglass pole is higher than the wood pole if the pole length, impulse polarity and test conditions were the same for both tests.

Under wet condition and positive lightning impulse, the CFO voltage strength of the fiberglass pole, the strength of CFO voltage per foot, decreased from 170 kV/ft, at 1 foot, to 120 kV/ft at 8 feet. The CFO voltage strength of the fiberglass pole is approximately 20 kV/ft higher than the wood pole.

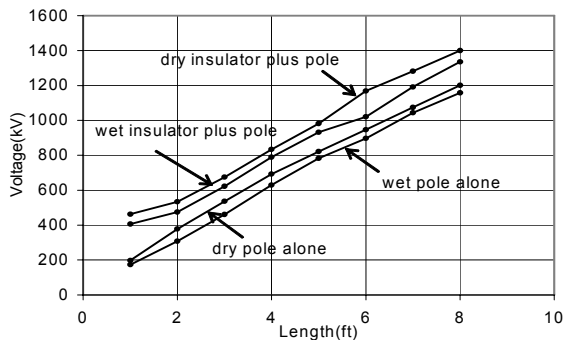
Fig. 2. The CFO voltages of 35 kV polymer suspension insulators plus the fiberglass pole and the CFO voltage of fiberglass pole, under dry and wet conditions, positive lightning impulse

The 15 kV, 25 kV, and 35 kV polymer suspension insulators and porcelain pin insulators were used in the laboratory investigation. CFO voltages of 35 kV polymer suspension insulators plus fiberglass pole, the CFO voltages of the fiberglass pole under dry and wet conditions, at positive lightning impulse are presented in Figure 2.

The CFO voltages of polymer suspension insulator plus fiberglass pole exhibit a linear relationship with the evaluated pole length. If the tested pole length is the same, the CFO voltage of polymer suspension insulators plus fiberglass poles is the highest at negative lightning impulse and dry conditions; and it is the lowest at positive lightning impulse and wet conditions.

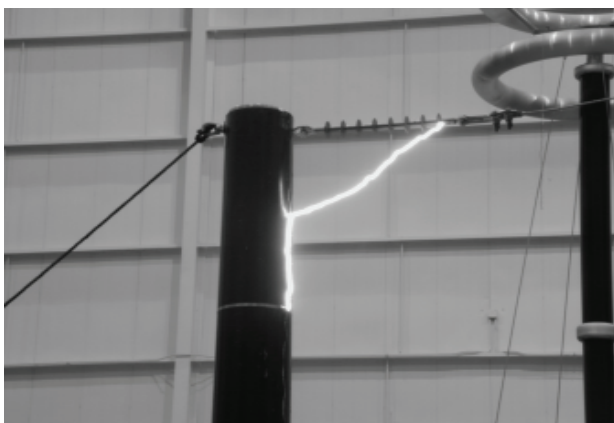
Fig. 3. The 35 kV polymer suspension insulator plus fiberglass pole, the tested pole length is 2 feet. The discharge took place in the air and on the surface of the pole

The CFO voltages of 15 kV, 25 kV and 35 kV porcelain pin insulators plus fiberglass pole were also evaluated and the similar conclusions can be drawn from the test results. The different discharge paths were observed in the tests and presented in Figure 3 and Figure 4.

When the pole length is 1 foot, the discharge happened in the air gap, which indicates that the lightning impulse strength of the suspension polymer insulator plus fiberglass pole is higher than the air gap between the energized insulator and the grounded electrode. When the pole length was 2 feet or above, the discharge paths always initiated from energized insulator and terminated on the pole surface about 1 foot below the top of the pole though the air, then developed on the surface of the pole until the grounded electrode was reached. Some times the discharges appeared around the suspension insulator surfaces and the pole surfaces. Therefore, the lightning impulse strength of the air gap between the energized insulator and grounded electrode became higher than the surfaces of insulator and pole in this case.

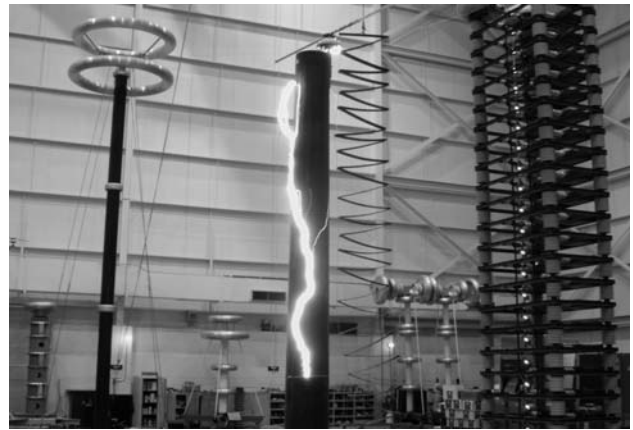
Fig. 4. The 35 kV porcelain pin insulator plus fiberglass pole, the tested pole length is 8 feet. The discharge developed on the surface of insulator and the pole

When the distribution line pole structure of porcelain pin insulator and fiberglass pole was tested, the discharge paths are different from those of polymer suspension insulator. In this insulation structure, the discharge initiated from the energized insulator, and is developing around the surfaces of the insulator and the pole, because the surfaces of the insulator and pole have the least lightning impulse strength.

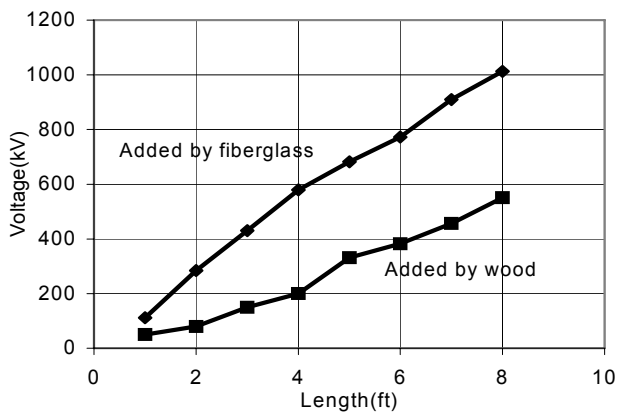
Fig. 5. The Added CFO voltages by fiberglass and wood poles to 15 kV polymer suspension insulators, wet condition and positive polarity lightning impulse

Figure 5 illustrates the Added CFO voltages by the fiberglass and wood pole to 15 kV polymer suspension insulators at wet conditions and positive lightning impulse. From Figure 5, it can be found that the Added CFO voltage by the fiberglass pole is much higher than the wood pole. This indicates that the lightning impulse strength of the distribution line structure with fiberglass pole can be greatly improved if fiberglass pole is used as a second insulation component.

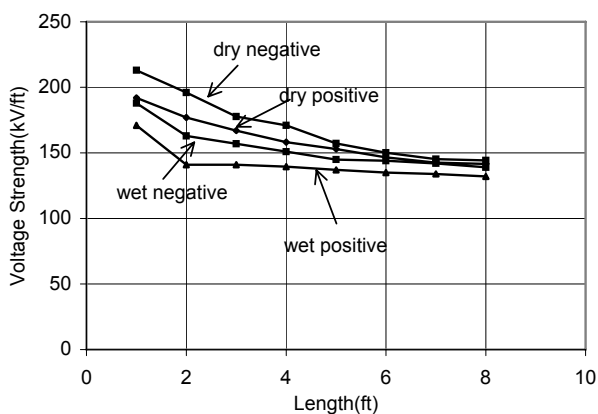
Fig. 6. The Added CFO voltage strengths by fiberglass pole to 35 kV porcelain pin insulators

Figure 6 illustrates the Added CFO voltage strengths by fiberglass pole to 35 kV porcelain pin insulators. The Added CFO voltage strength to porcelain pin insulator almost decreases with the increase of the pole length

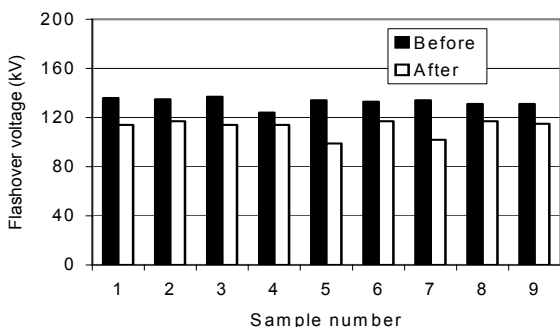
Fig. 8. AC flashover voltages of fiberglass samples tested before and after 1000 hours aging in salt fog, under dry condition

Figure 7 presents the CFO voltages for samples tested before and after 1000 hours aging in salt fog. Figure 8 presents the ac flashover voltages for samples tested before and after 1000 hours aging in salt fog. Figure 9 presents the corresponding ac leakage currents for samples tested before and after 1000 hours aging in salt fog.

The CFO voltages and the ac dry and wet flashover voltages were lower than before the aging tests, especially in the wet tests. The leakage currents were two or three times higher than before the aging test. The electrical strengths of the samples decreased significantly after exposure to salt fog for 1000 hrs.
